# Manhole Inspection Summary

Manhole # S13A\_\_032MH

Insp Date: **12/3/07 2:41 PM**

**Location** Address: **REAR OF 2864 LANVALE ST** Cross Street: **POPLAR GROVE ST**

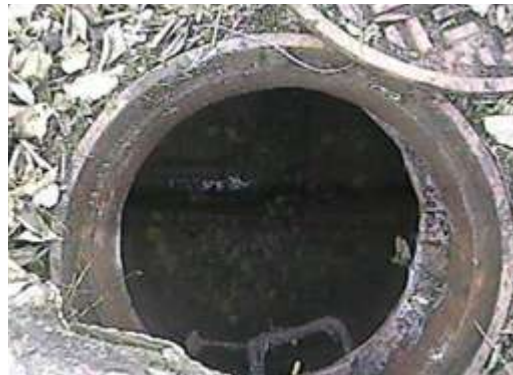
Defect 2

**Frame** Offset: **3** (in.) Condition: ☒ Sound ☐ Cracked ☐ Leaks

OFFSET FRAME

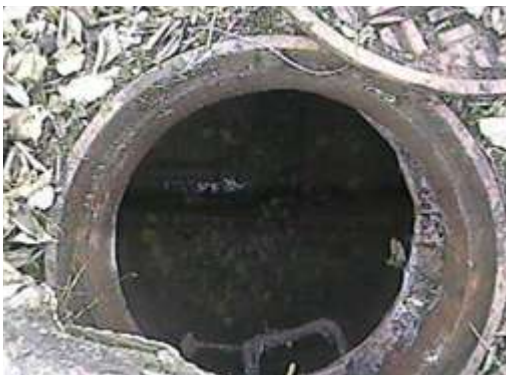
Defect 1

**Steps** Count: **3** Missing: **0** ☒ **Corroded**

CORRODED STEPS

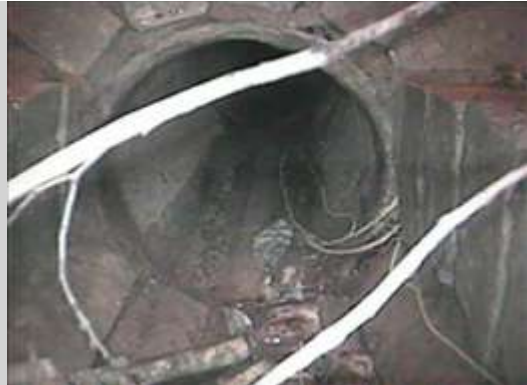
12 O'Clock Outflow

ROOTS AT PIPE SEAL.

Infiltration: **None** Pipe Seal Cond: **Roots**

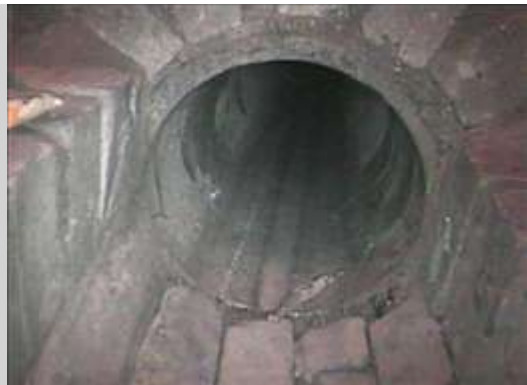
9 O'Clock Inflow

Invert Depth: **6.05** (ft.) Flow Characteristics: **Slow**

Infiltration: **None** Pipe Seal Cond: **Sound**
